The Self-Recovery of Stream Channel Stability in Urban Watersheds due to BMP Implementation

March 2021

Prepared by the Center for Watershed Protection, Inc.

Prepared for the Carroll County Bureau of Resource
Management

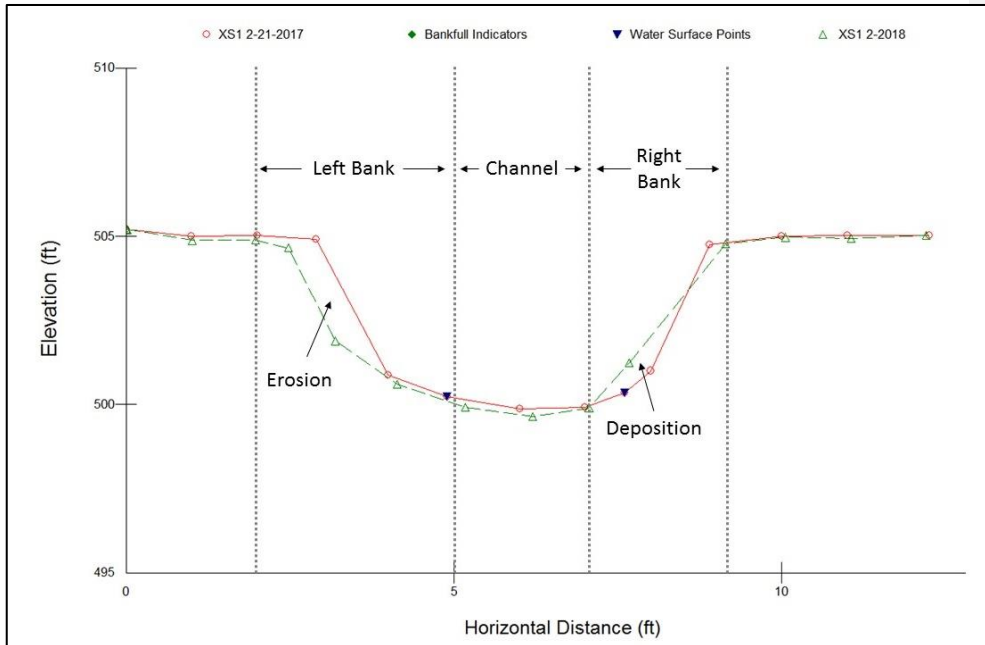
Figure 4. Cross-section change division between the left bank, right bank, and channel change areas.

each cross-section. Figure 4 shows an example of the division between the left bank, right bank, and channel change areas.

Changes in cross-section area were calculated for both bankfull depth and total channel area extending to the top of bank. Area was calculated using RiverMorph and estimates of bankfull depths were obtained from the BANCS assessments. Bankfull field indicators were difficult to determine in the study reaches. As such, bankfull was approximated as 1 foot above the toe of slope for Central MD SVC, Shannon Run, and Piney Ridge. Bankfull depth was approximated as 0.8 feet above the toe of slope for Robert’s Field. These bankfull depths were based on the USFWS Piedmont Regional Curve (USFWS, 2002) to ensure the approximate depths were appropriate. The same bankfull elevations at each cross-section were used for both the pre and post-treatment cross-section area calculations. The area of change was divided by the monitoring period length (in years) for the pre- and post-treatment periods to normalize the percentage of change that occurred on a per-year basis.

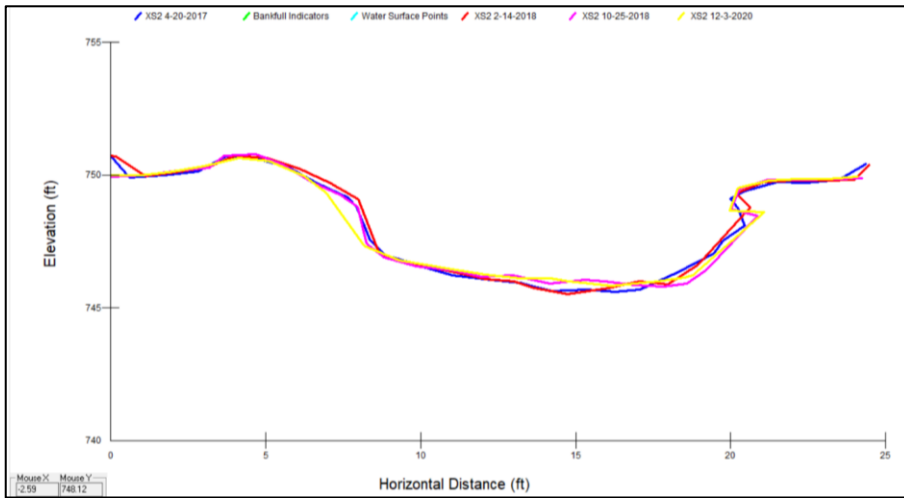
Figure 15. Robert's Field cross-section 2 showing an undercut right bank and left bank that eroded during the end of the post-treatment period.

Example cross-sectional profiles are shown in Figure 12 – Figure 15 illustrating the erosion that occurred during the pre- and post-treatment periods. Shannon Run and Piney Ridge both exhibited undercutting and bank retreat, with Shannon Run showing the greatest degree of undercutting. Cross-section changes at these two sites are the more pronounced of all the study sites, but also had the longest pretreatment time period, extending from April 2017 to October 2018. The pretreatment period at the other study sites ended February 2018.

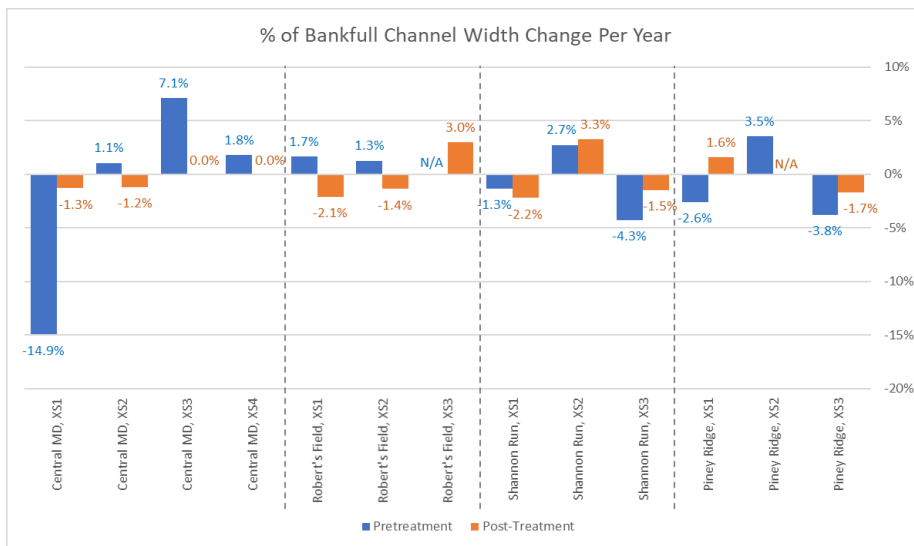
Figure 20. Percentage of bankfull channel width change per year.

The cross-section channel widths at the bankfull depth (Figure 20) and top of bank (Figure 21) were calculated to determine if any patterns of channel widening occurred. No discernable patterns of channel width change were determined.

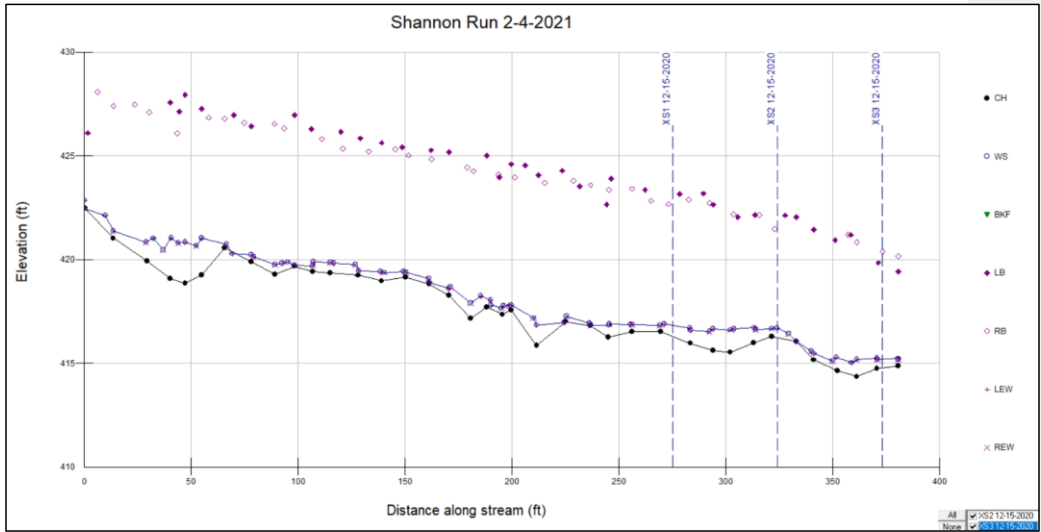
Figure 22. Shannon Run post-treatment longitudinal profile.

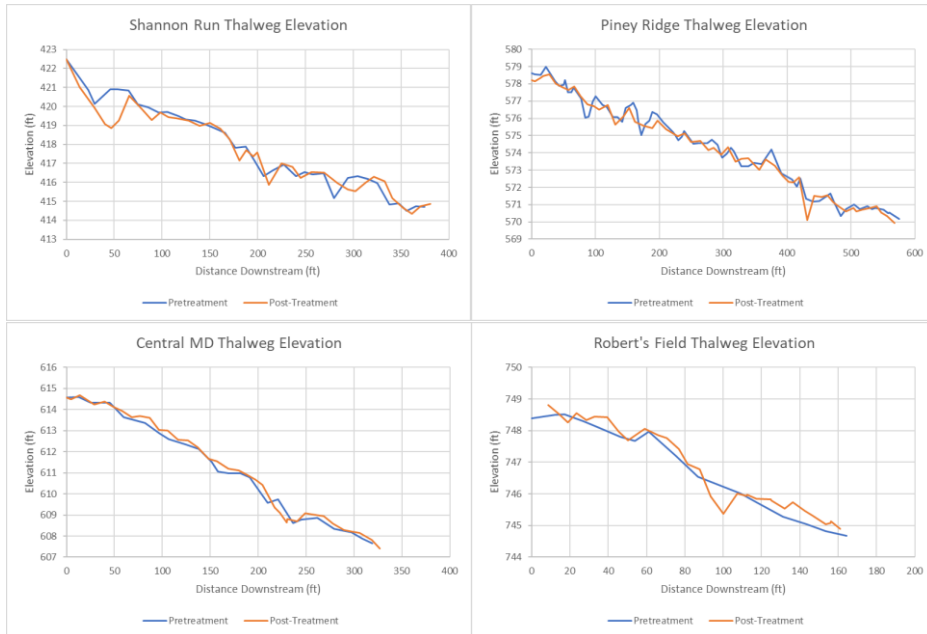
Figure 23. Longitudinal profile thalweg elevation change.

The pre- and post-treatment thalweg elevations were also compared at each of the study sites (Figure 23) to determine if patterns of bed aggradation and degradation could be observed. Central MD SVC, a treatment site, exhibited systemwide aggradation indicative of a trend toward stability as per the Channel Evolution Model. However, so did the Robert’s Field control site. Shannon Run (treatment) and Piney Ridge (control) exhibited both aggradation and degradation.

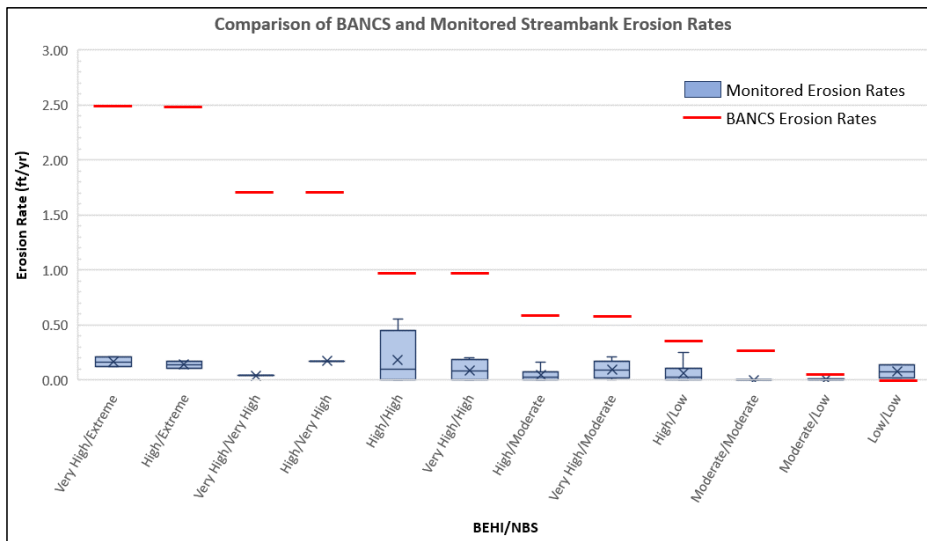
Figure 29. Comparison of BANCS and monitored streambank erosion rates.

Table 14 and Figure 29 provide a comparison between the BANCS estimated erosion rates and the monitored erosion rates from bank pins and cross-sections. This comparison was made at the point where the BANCS assessed reaches and monitoring locations overlap (i.e., the monitored erosion rates correspond to the eroding bank and are not representative of the entire channel). The data includes erosion rates from both the pre- and post-treatment monitoring periods due to the limited sample sizes of comparing each of these monitoring periods individually. Only eroding reaches determined from the BANCS assessments are compared with the monitored erosion rates. All the BANCS estimated erosion rates were higher than those monitored, except for reaches with a BEHI/NBS characterization of low/low. The differences between the estimated and monitored erosion rates become increasingly more pronounced when moving from the low to very high BEHI and NBS characterizations. Less than 5 monitored erosion rates are available for all the BEHI/NBS characterizations, except for high/high (n=12), high/moderate (n=12), and high/low (n=23). Even with these characterizations with higher sample sizes, the monitored erosion rates were lower than estimated from BANCS. Monitored erosion rates across all BEHI/NBS characterizations were less than 0.5 ft/yr, while BANCS ranged from 0.03 to 2.5 ft/yr.

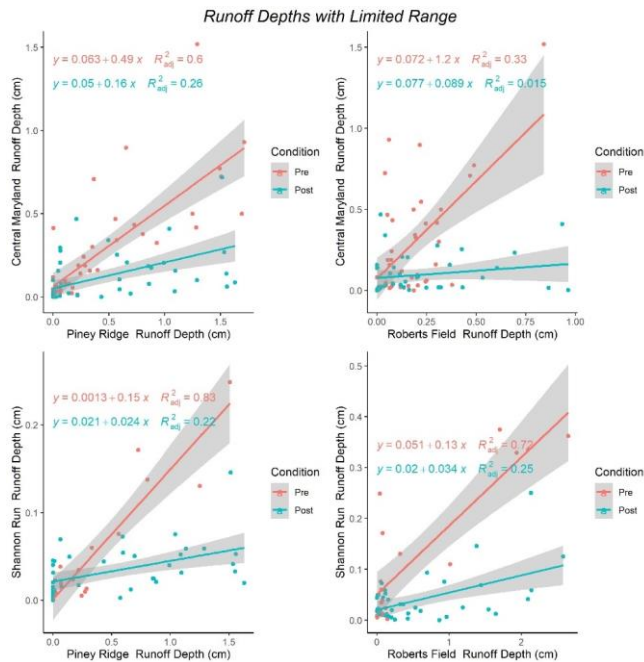
Figure F-2. Restricted Suite of Storms Runoff Depth Comparisons

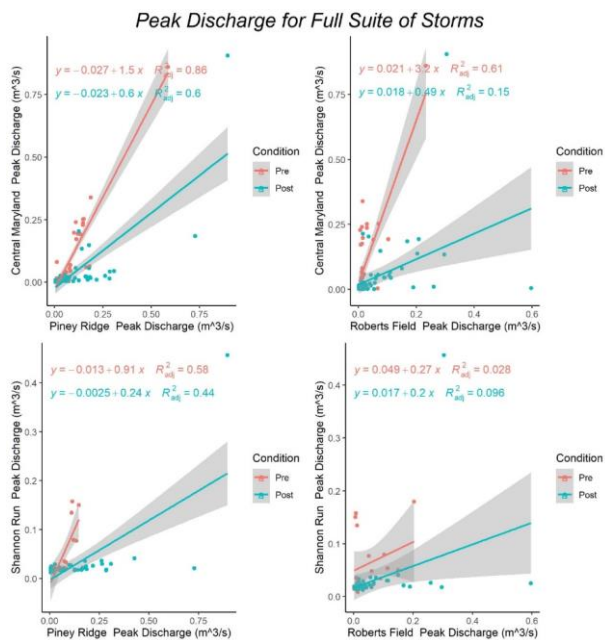
Figure F-3. Full Suite of Storms Peak Discharge Comparison

The initial data set also included peak discharges for the post-treatment condition that were much greater than the depths experienced (in the control watersheds) in the pretreatment condition (Figure F-3). To resolve this issue, data sets were limited to events where the pretreatment control peak discharge was less than 0.25 m³/s. This limited data set (Figure F-4) was used to evaluate the change in peak discharge (slope between control and treatment watersheds) between the pre- and post-treatment conditions.

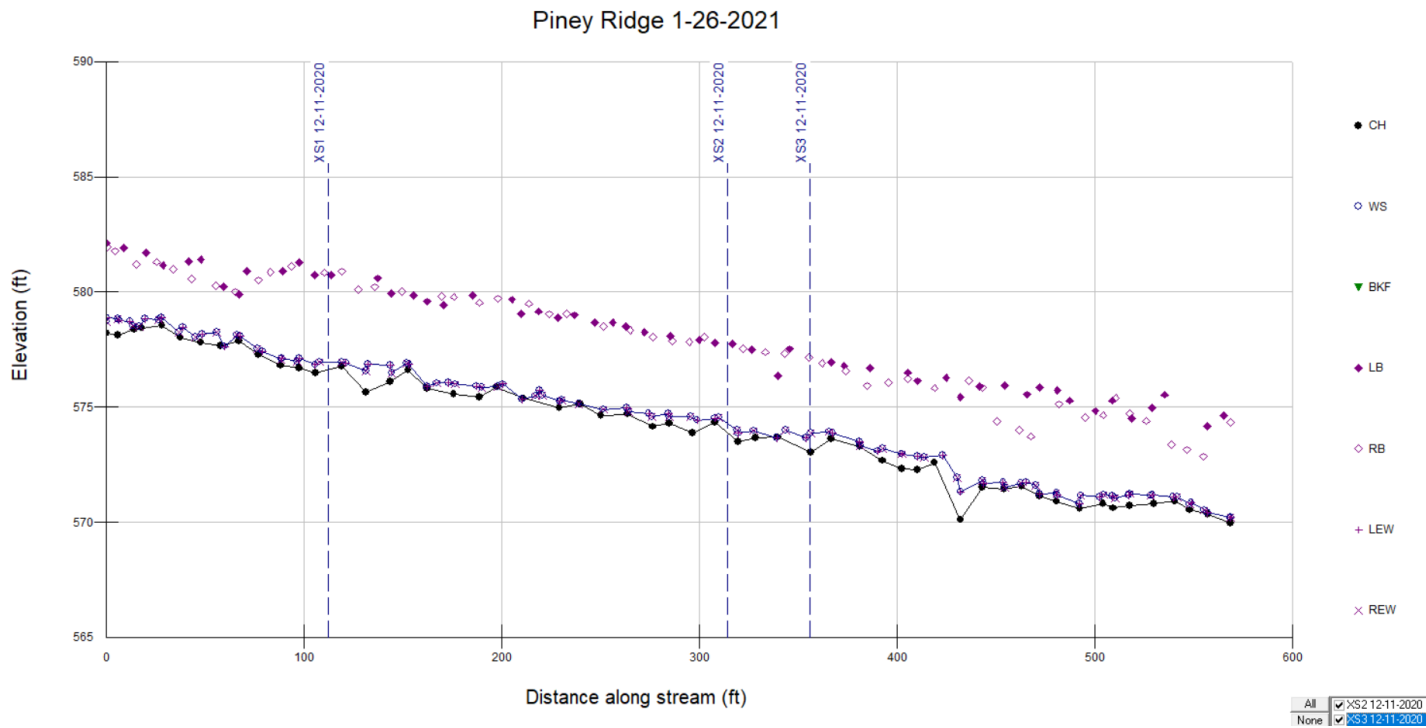
Figure I-8. Piney Ridge post-treatment longitudinal profile.
